Manhole Inspection Summary

Manhole # S17I__037MH

Insp Date: **6/15/09 12:30 PM**

Location Address: **2406 W BALTIMORE ST**

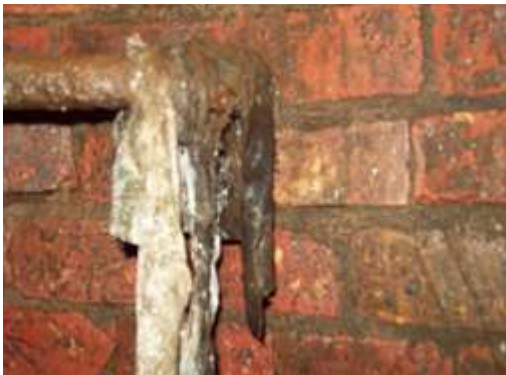
Defect 1

Surcharge ☒ **Evidence Of Surcharge** Depth: **26** (ft.) ☐ Active Surcharge Present

EVIDENCE OF SURCHARGE

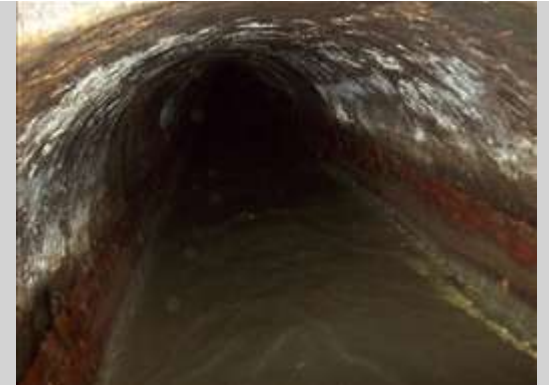
12 O'Clock Outflow

54 in. Circular Gravity Sewer
Pipe Out @ 12 O'Clock

Pipe Height: (in.) Direct
Pipe Material: **Unknown** ☐ Pipe Lined
Invert Depth: **28.62** (ft.) Flow Characteristics: **Fast**
Deposits: ☒ None ☐ Mud ☐ Sludge ☐ Debris ☐ Grease
Silt Depth: (in.) Deposits Extent:
Infiltration: **None** Pipe Seal Cond: **Sound**
